## Hummer's Meritor Wabco ABS Modulator

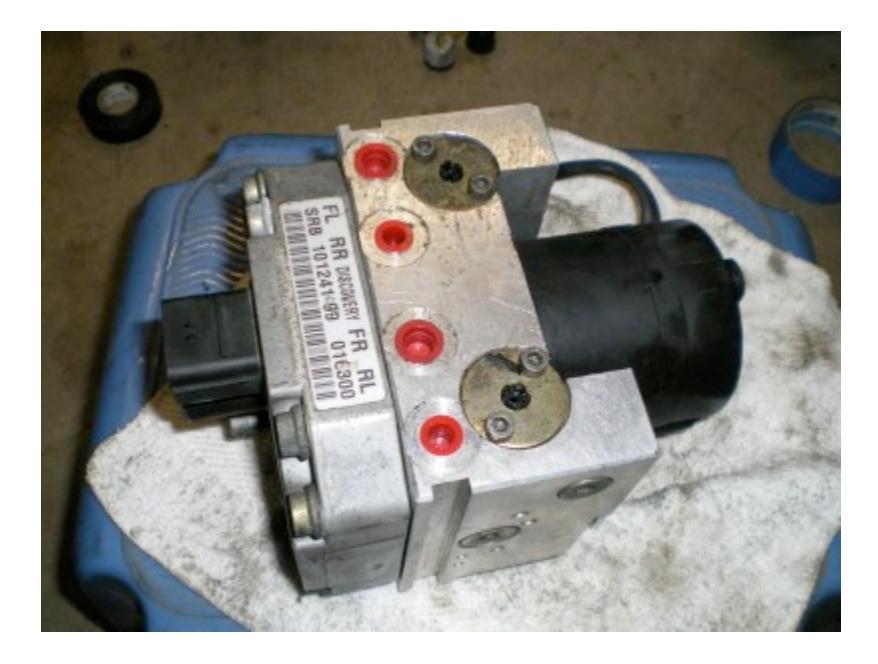
The code 2-6 gives a shuttle valve switch failure as the cause and the fix is to replace the entire modulator assembly. Following the service manual it is not too difficult to remove the modulator:

Unplug battery,

Remove drivers side splash shield, 3 bolts.

Remove horn bracket/disconnect horns, 2 bolts.

Disconnect hard lines from modulator, 4 lines to brakes, 2 from master cylinder.

Remove the modulator bracket from frame, 4 bolts.

Turn and twist contraption to pull bracket/modulator out from the top.

Pull the leading edge up the bracket up and out first allowed the rest to come out behind it. Remove modulator from bracket, 4 bolts.

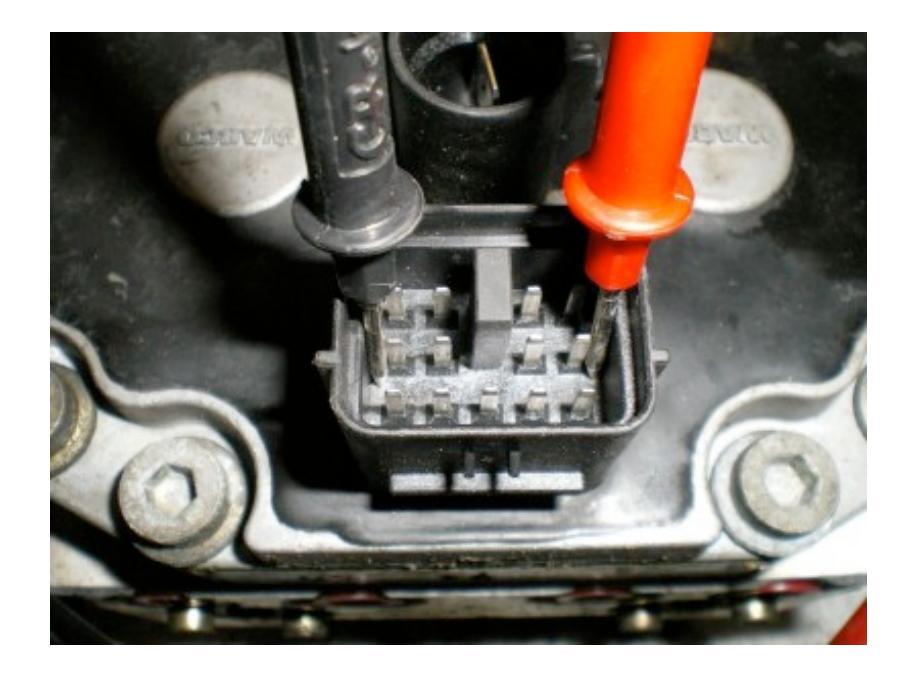
Once I removed the modulator I could jump the pins on the connector to test the shuttle valve. When connecting pins 6 and 9 (IIRC its connector C1, 13 pins) on the back of the modulator with an ohm meter I was getting nothing. There should be a resisted connection between the two pins.

This is part of AM General's test procedure that verifies that the shuttle valve is bad, except you can do theirs directly at the ABS ECU connector (pins 25 and 27).

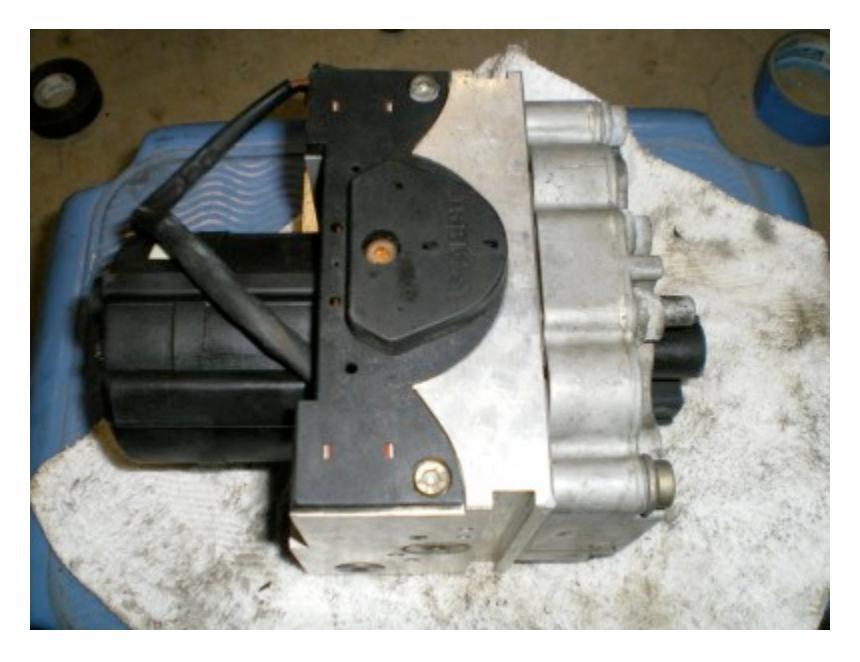
Okay so back on track this gave me no connection between pin 6 and 9. The shuttle valve is located on the bottom of the modulator, it's a piece of black plastic that runs the span of the modulator and is held in with three Allen head screws.

I took the side of my ratchet/socket wrench and tapped on that box with the ohm meter hooked to the pins. There in lies my problem, I would tap it and the connection would open up allowing current to pass through, tap again and it's gone, and so on.

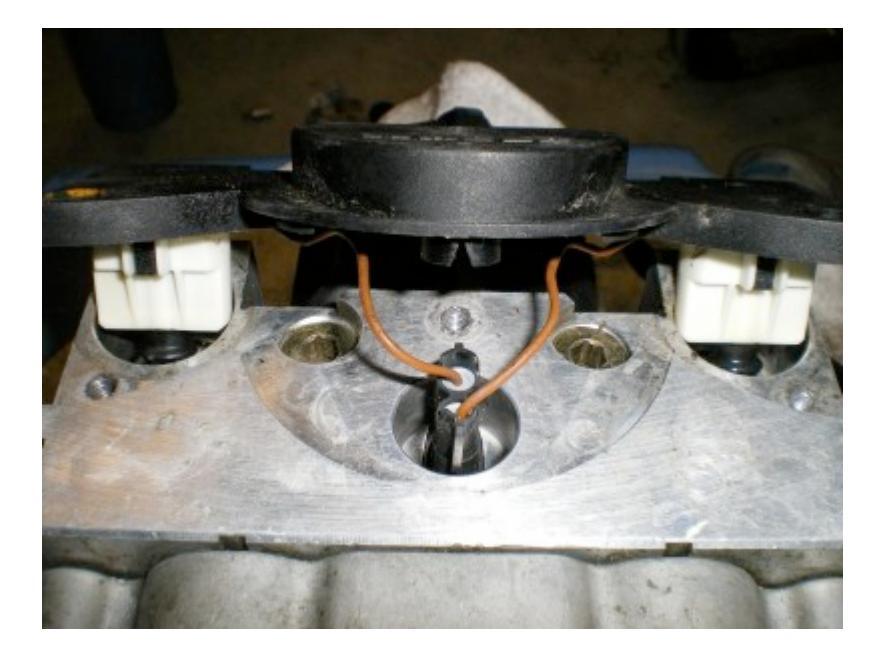
I removed the three Allen head screws that hold the shuttle valve onto the modulator and pulled the shuttle valve off, it is a press fit so it may take a slight force.

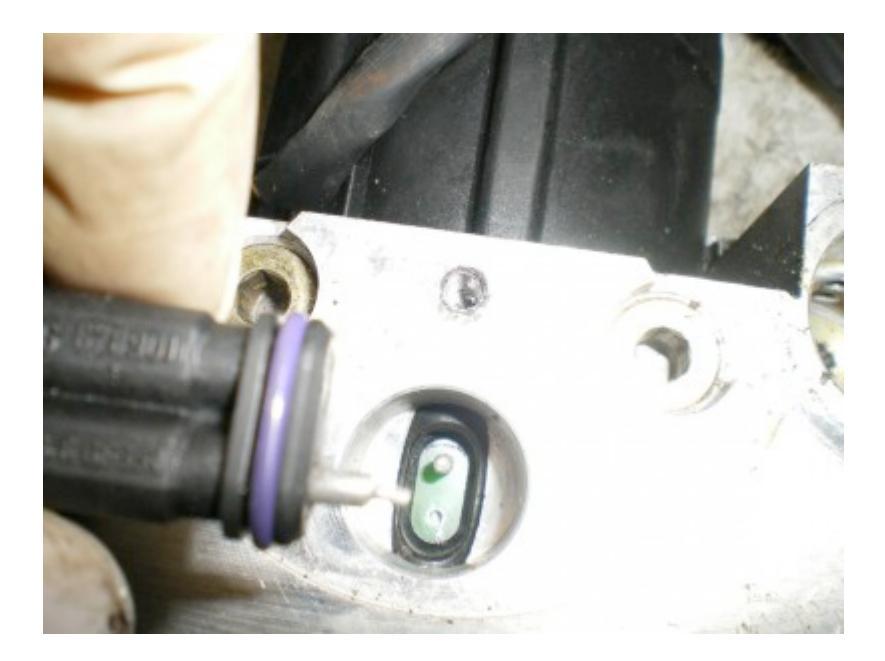
At this point I hooked the ohm meter back up on the two pins and realized that just by moving the shuttle valve around I could get the connection to come and go. I pulled the shuttle valve electrical connector off and removed the shuttle valve. I then ran the ohm meter across this two pin connector and started jiggling the wires, the connections were all good, there was a certain ohm at rest, another ohm with one plunger pushed and another reading with both plungers pushed, this meant my shuttle valve was good. Yes the pin in the connector is not supposed to be there, it's still supposed to be in the circuit board in the modulator!

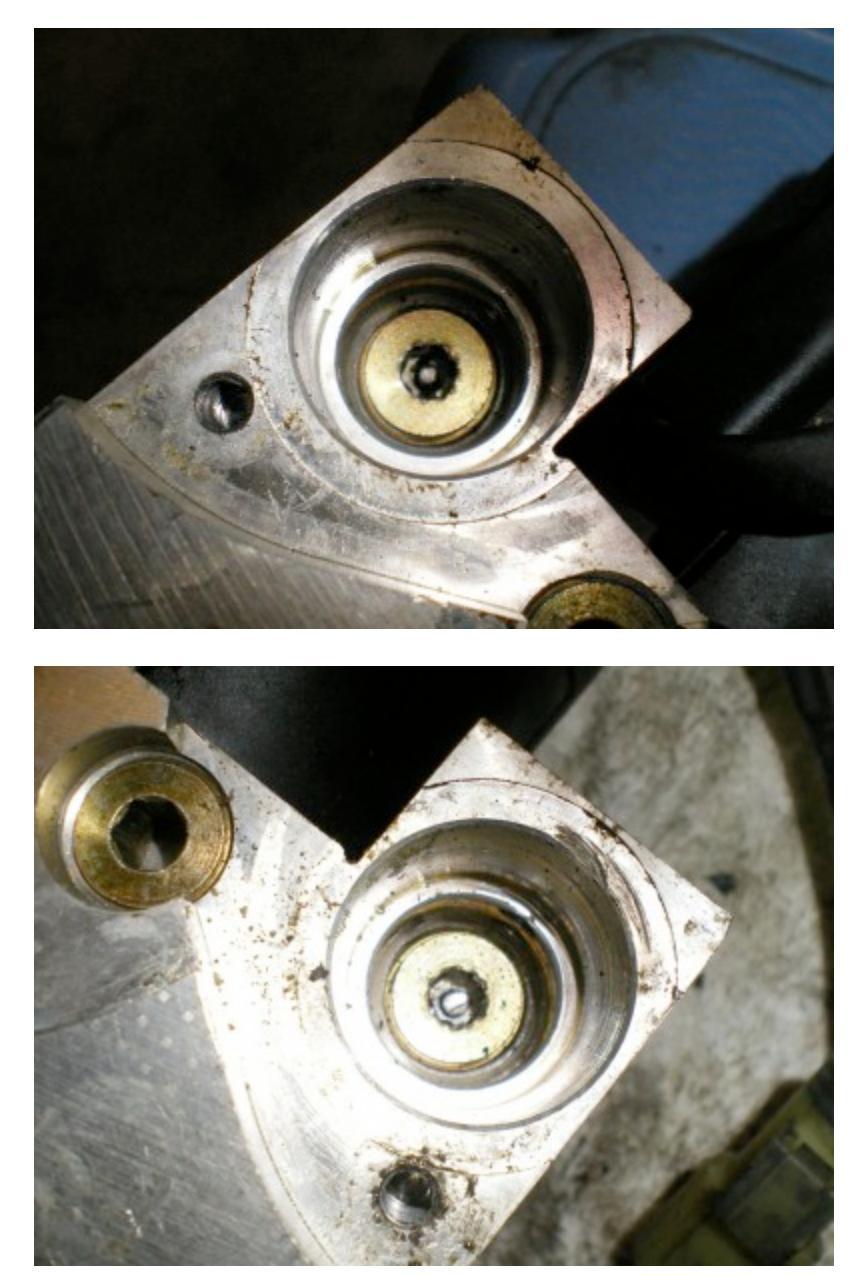
Here's some insight into how the shuttle valve works, the plungers are activated by two different diameter plungers located within the modulator. The more pressure you put on the brake pedal, it activates the two different plungers accordingly. That is how your vehicle knows if your not braking, lightly braking, or to the floor "oh crap" braking.

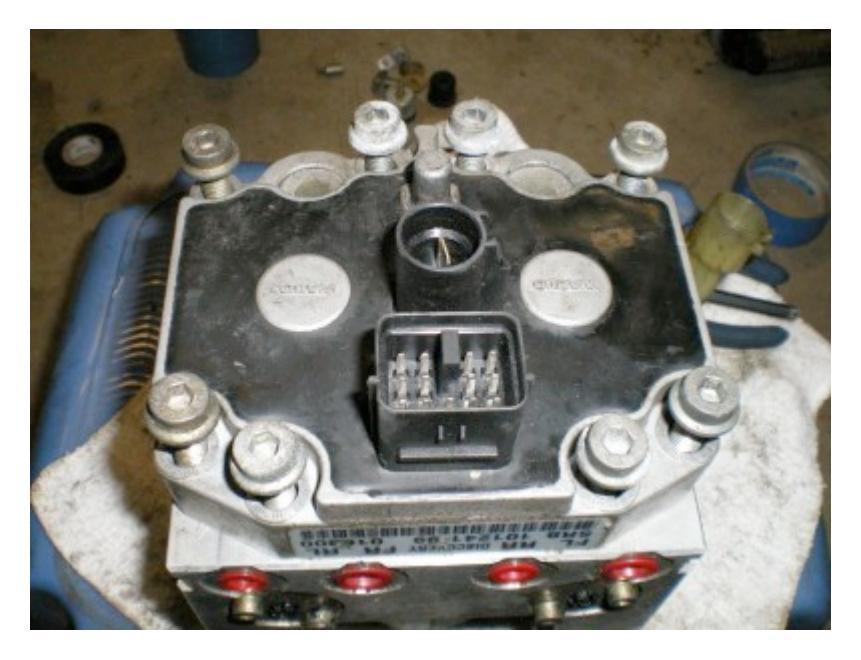
Back on track this left me with a problem in the connector. This is where the internet did its purpose and allowed me to find another Land Rover owner who did this same process. There are eight bolts holding the two halves of the modulator assembly together. Remove these eight bolts and make sure your shuttle valve is not connected.

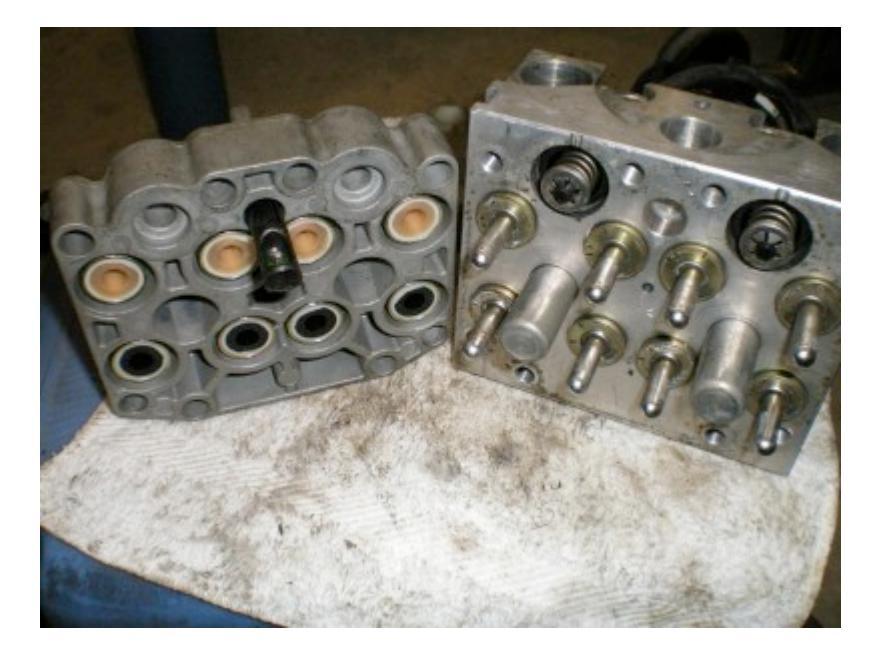
You might have to lightly pry the two halves apart and you will see the inner workings of the solenoids and valves that control your brakes and wheel spin for both abs and TT4. These silver rods move in and out in order to control which wheels receive the hydraulic pressure in the caliper. Don't worry there is nothing loose inside here that can fall out or move on its own.

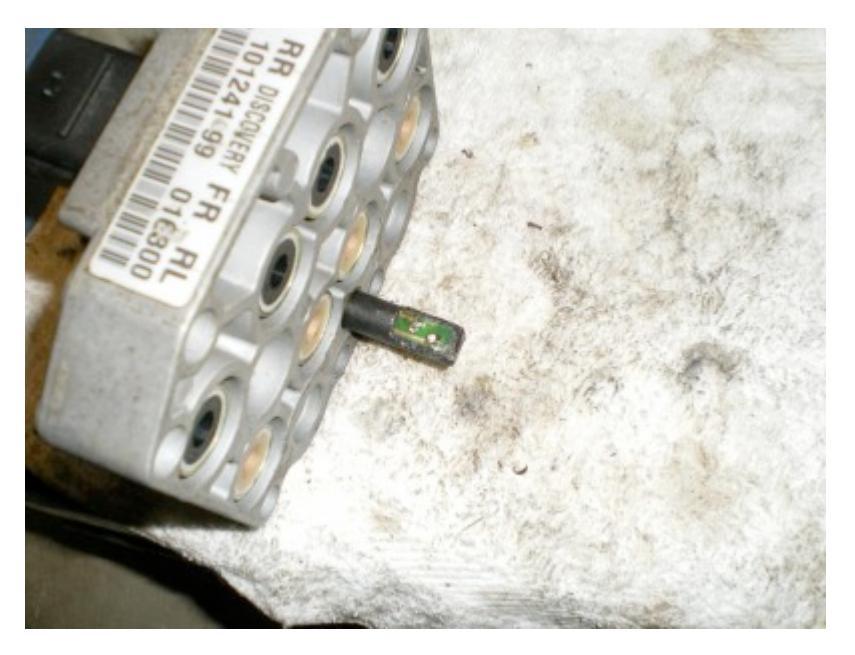
On the \*lower\* portion of the thin half of the case you will see a black plastic rod sticking out. It's obvious. This is where the shuttle valve connects to the circuit boards of the modulator.

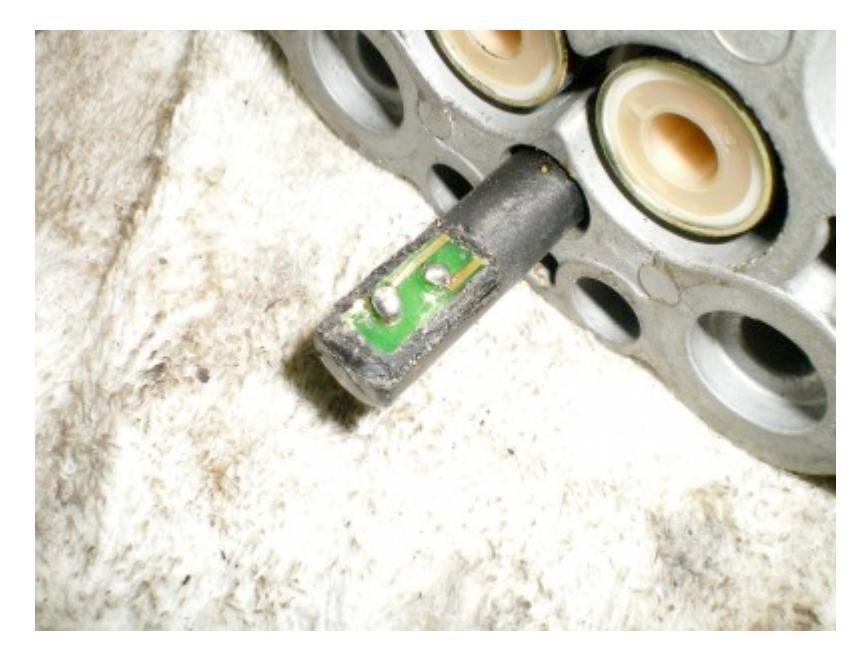
This is where the problem is for some of us with reoccurring shuttle valve problems (erratic lights on and off) and this explains why both some of my rebuilds would work and some wouldn't. When they disconnected the old shuttle valve to put this one back in, they would move this connection enough to get it back to having a solid connection within. Well I decided since my pin came out that was probably where the problem was, a very shoddy solder job at Merritor Wabco. The problem is that this black plastic connector/circuit board is encased in hard plastic. I heated up a razor blade (in a handle) with my trusty torch and began surgery to remove that back half of the plastic rod. I used the soldering iron to heat up the "factory" solder and reinserted the pin, and then I added a "little" more just to be sure. Be sure to hold the pins in the circuit board when heating the solder up, they will fall out if not held.

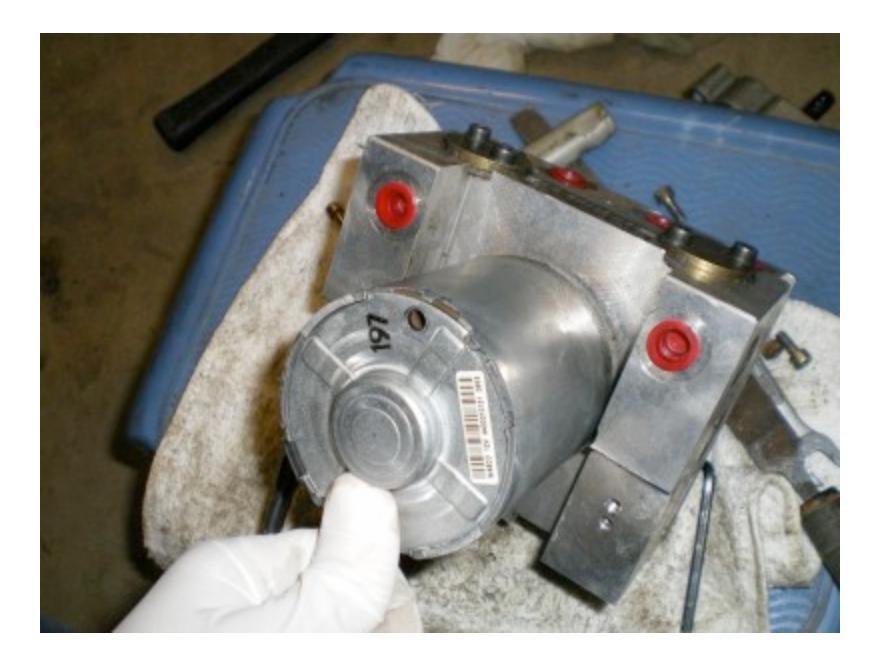
Pulled the cover off the motor and removed the two Allen screws holding the motor to the block (one broke in half actually, dissimilar metal welds?)

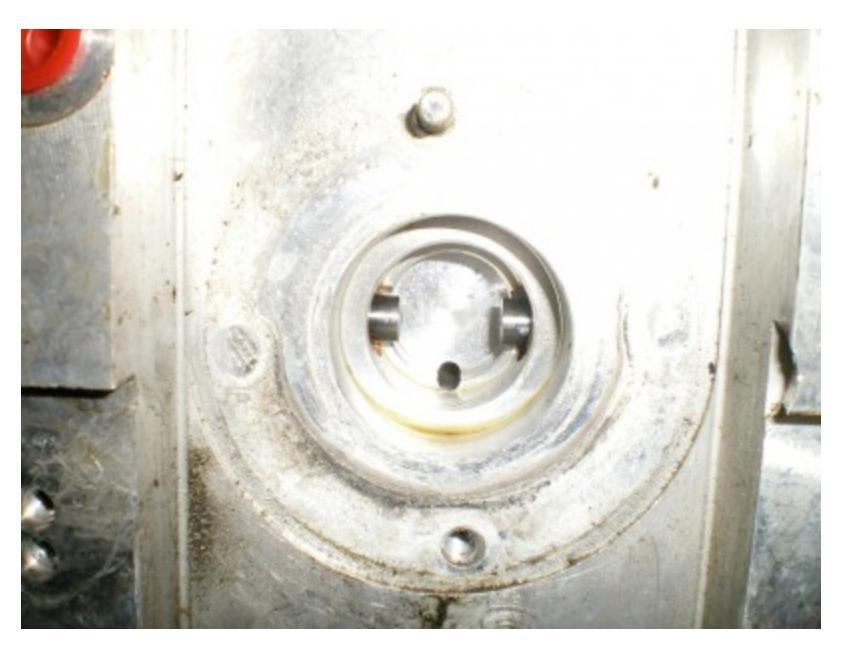
Here is what it looks like under the motor, those two pins work as mini brake pedals, you push one in and it develops line out pressure on its respective half of the modulator.

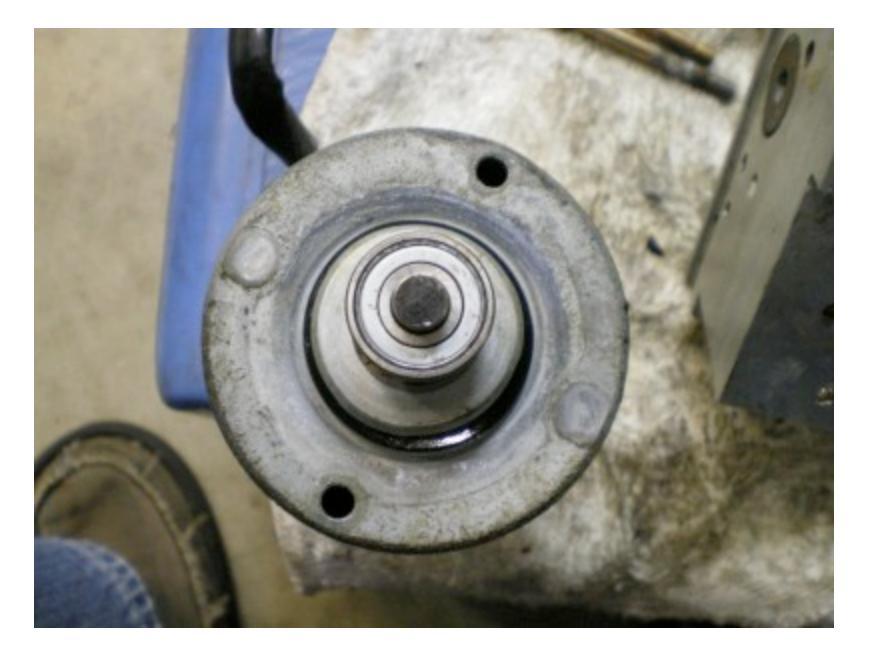
Here is what activates those two pins. As the motor spins, this bearing rides against the pins. You can kind of see how the bearing is offset of center.

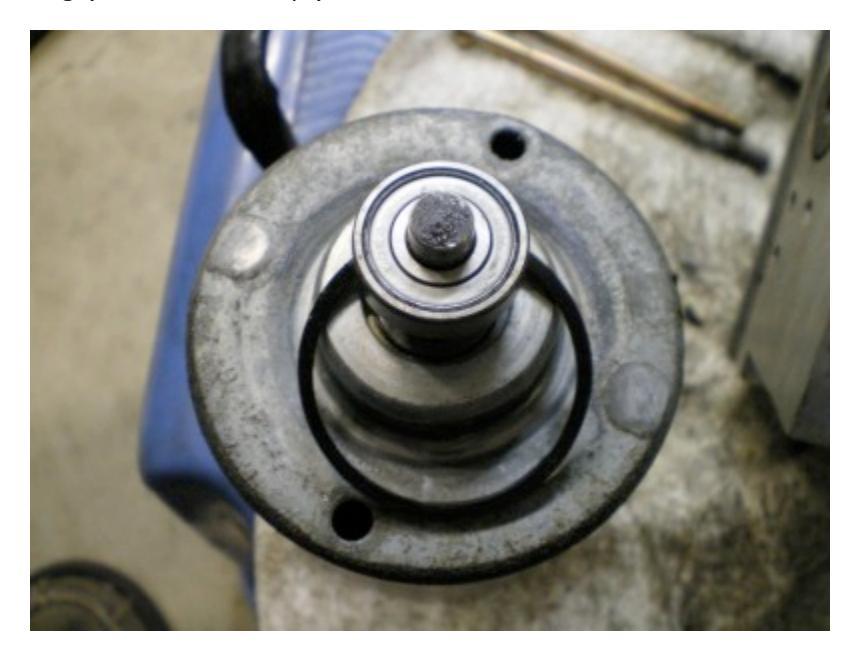
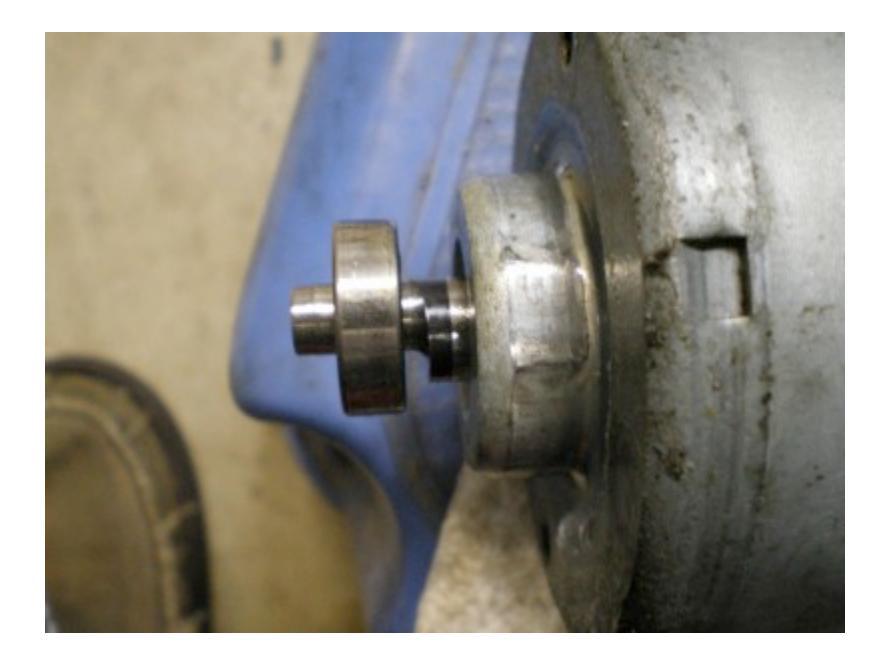
Here are two pics of the side of the modulator (and its O Ring!). As the motor spins the bearing in effect rolls side to side activating each plunger in sequence, developing pressure to run the TT4 and ABS brake at each wheel. This of this as two separate brake pedals, one controls the left side calipers, and one controls the right side calipers. I have a feeling that this offset creates a balance issue for the motor and this helps to create the buzzing feeling when the unit is running (the "UH OH" stop!).

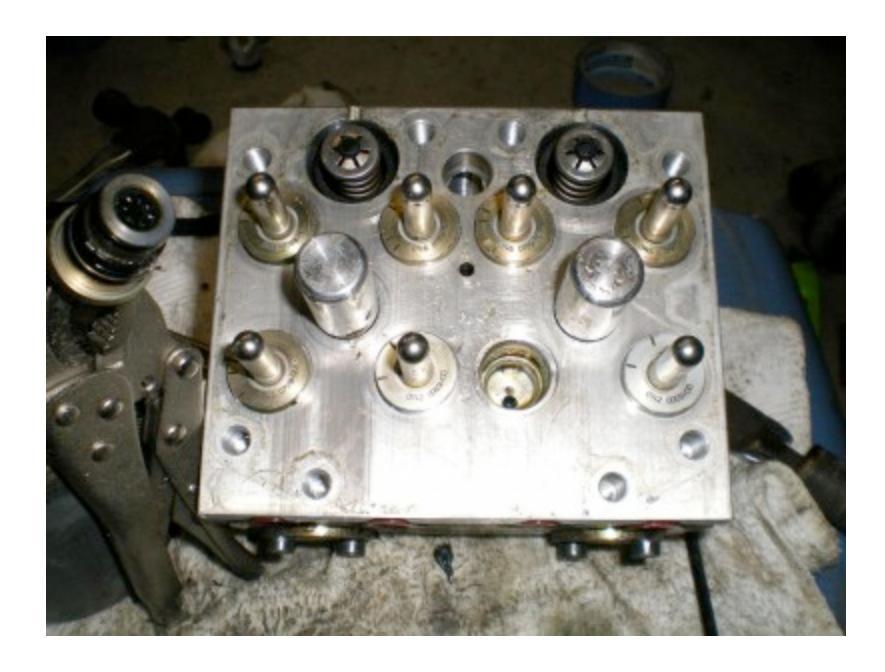
So I removed one of the "spikes". These go into a corresponding solenoid on the half of the modulator that is removed. Think of those as big magnets. When they are powered up they pull this pin back a slight bit and allow fluid to pass. I will assume some of the other pins pull back stop the flow of fluid. Four wheels, eight pins, it sounds plausible....

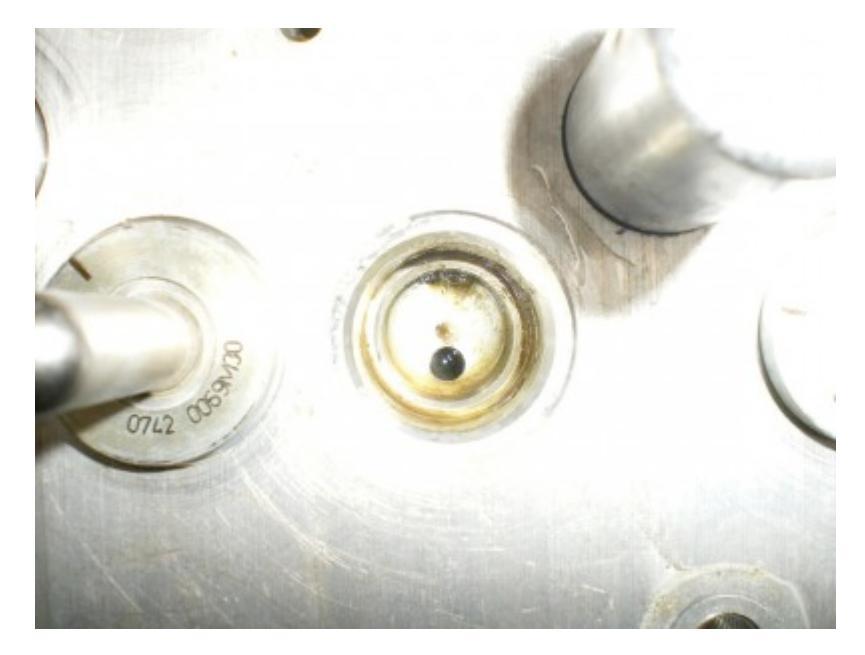
This shows where I believe the fluid comes in

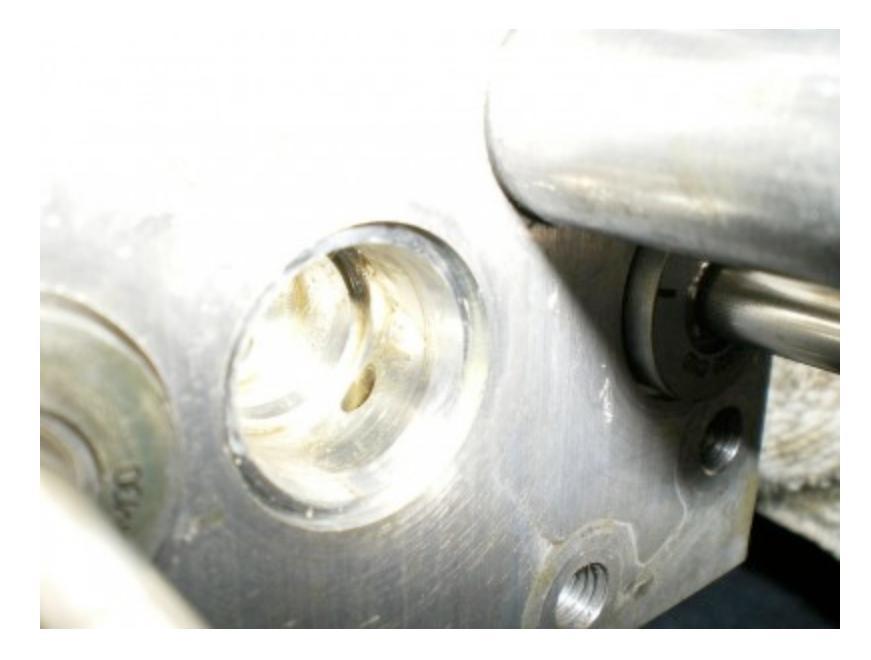
This is where it comes out?

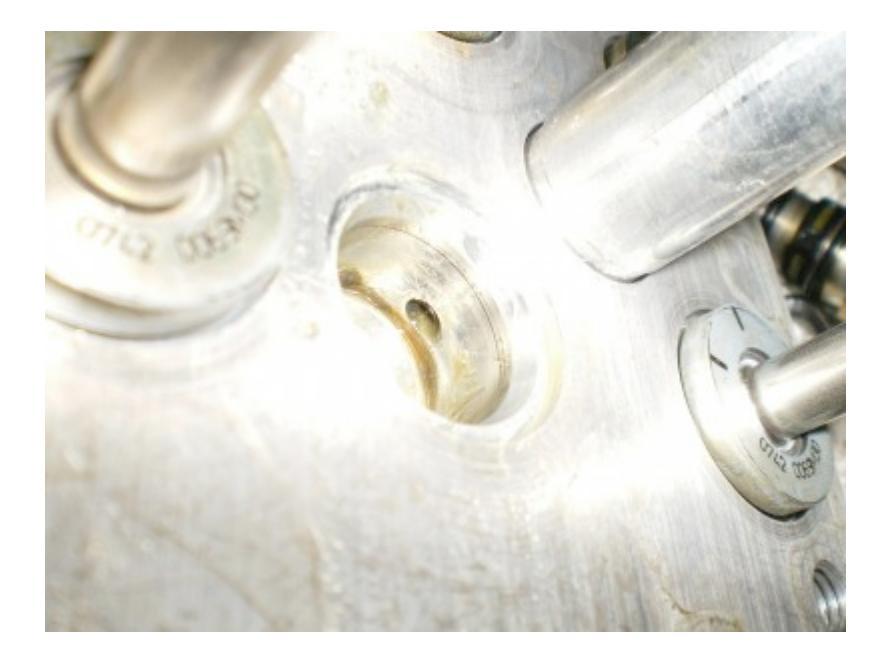
Here too?

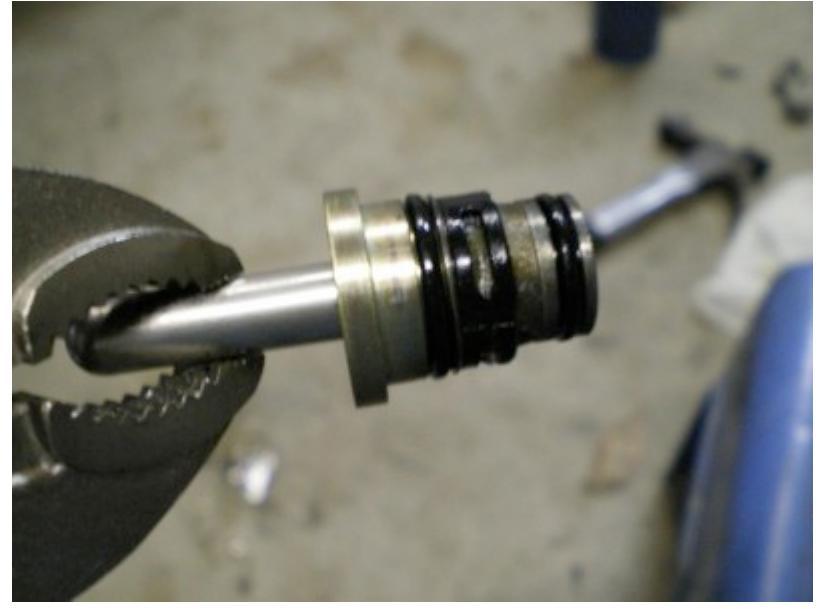
Side of pin, removed from block, seems like mesh in the oval opening of black rubber ring. Use of Vice Grips not recommended!

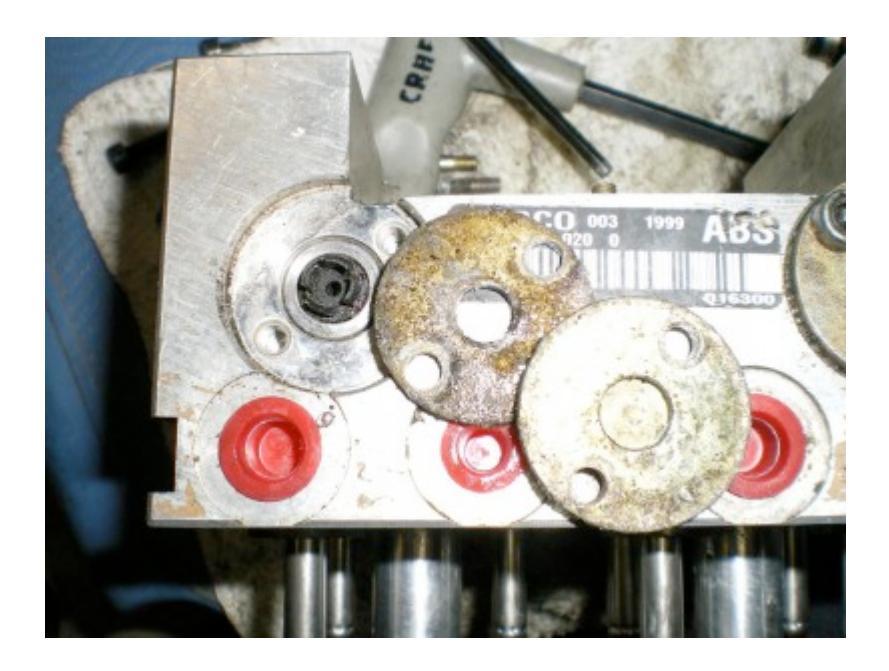
This is the big contraption right on the top of the modulator, you can see two of these on the top and they are visible while the modulator is still installed. These are different on different revisions of the modulators BTW. One is recessed, one sits up higher....

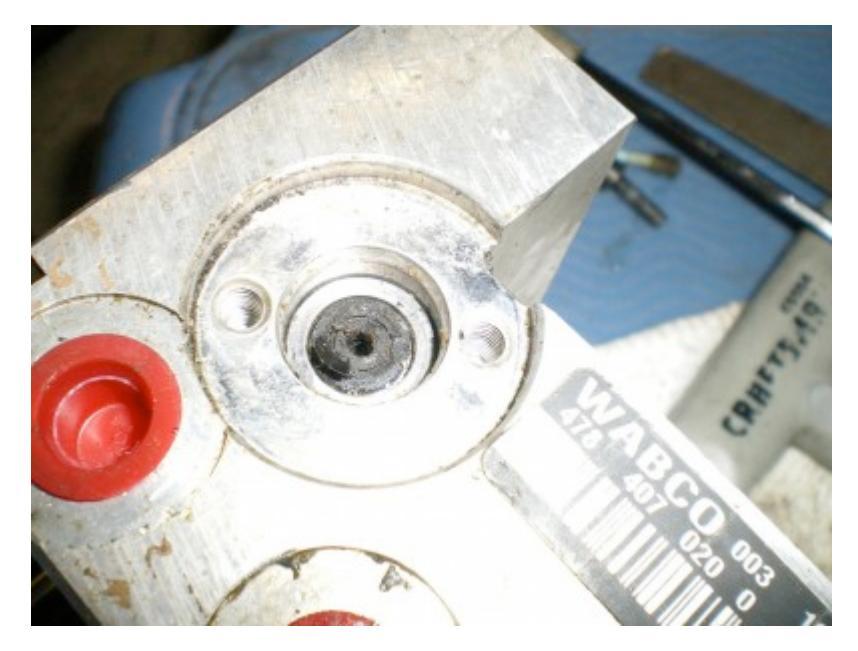
If you push on the black plastic in the center the cylinder moves down. Not sure what this does!

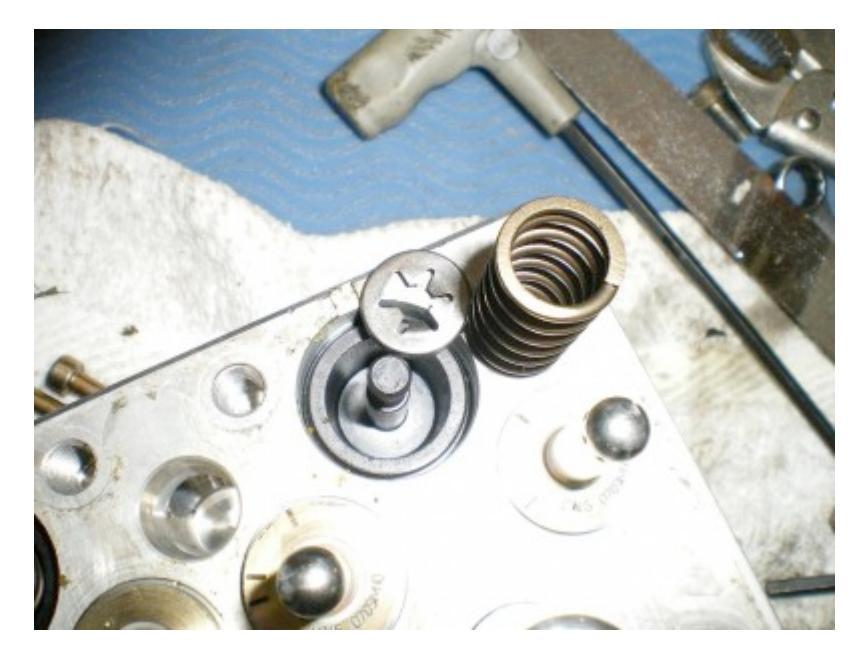
This is the big spring thing on the same side as the spikes, I have no idea what these are for, but they have a large recess into the other side so I assume they move one way or the other. Vice Grips could not get this one to budge.

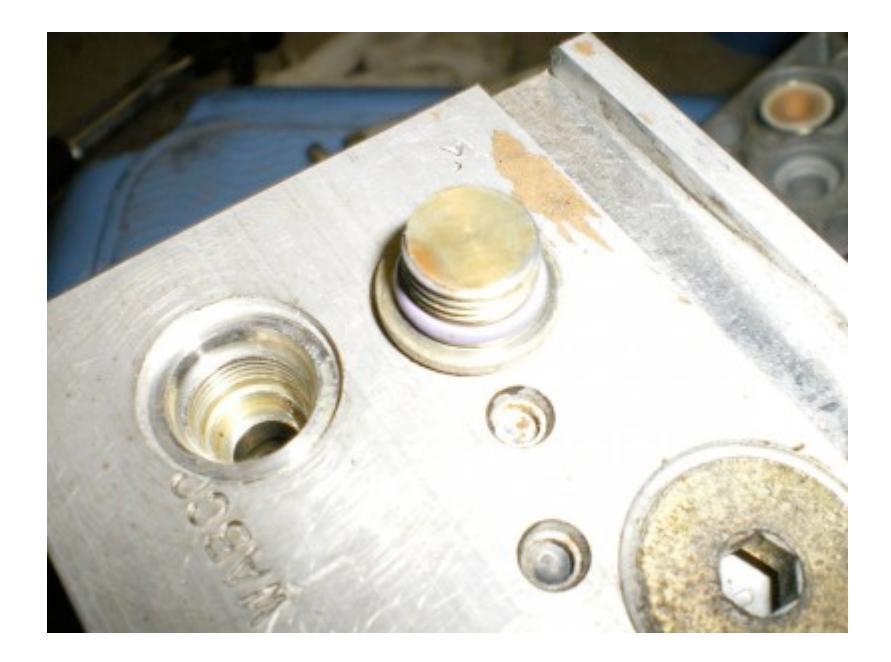
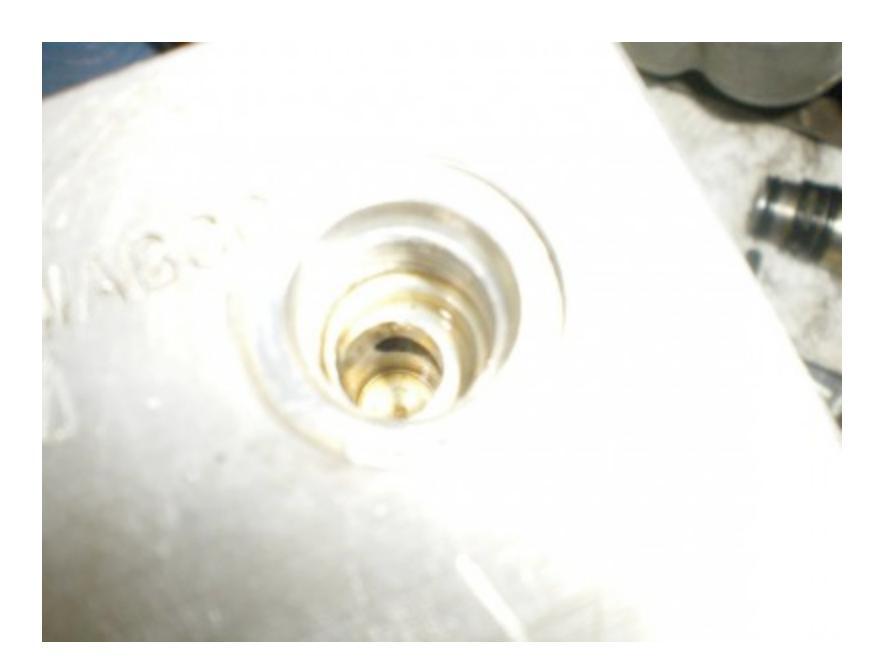
This is the smaller of the two plugs on the side (I think it's the side) of the housing. Have no idea what they do, but there are fluid transfer holes inside.
